GEOLOGIC AND GEOTECHNICAL INVESTIGATION

1925 EL CAMINO DE LA LUZ
SANTA BARBARA, CALIFORNIA

OCTOBER 2012

SUBJECT: **Geologic and Geotechnical Investigation**
RE: 1925 El Camino De La Luz
 (Proposed Single-Family Residence - APN 045-100-024)
 Santa Barbara, California

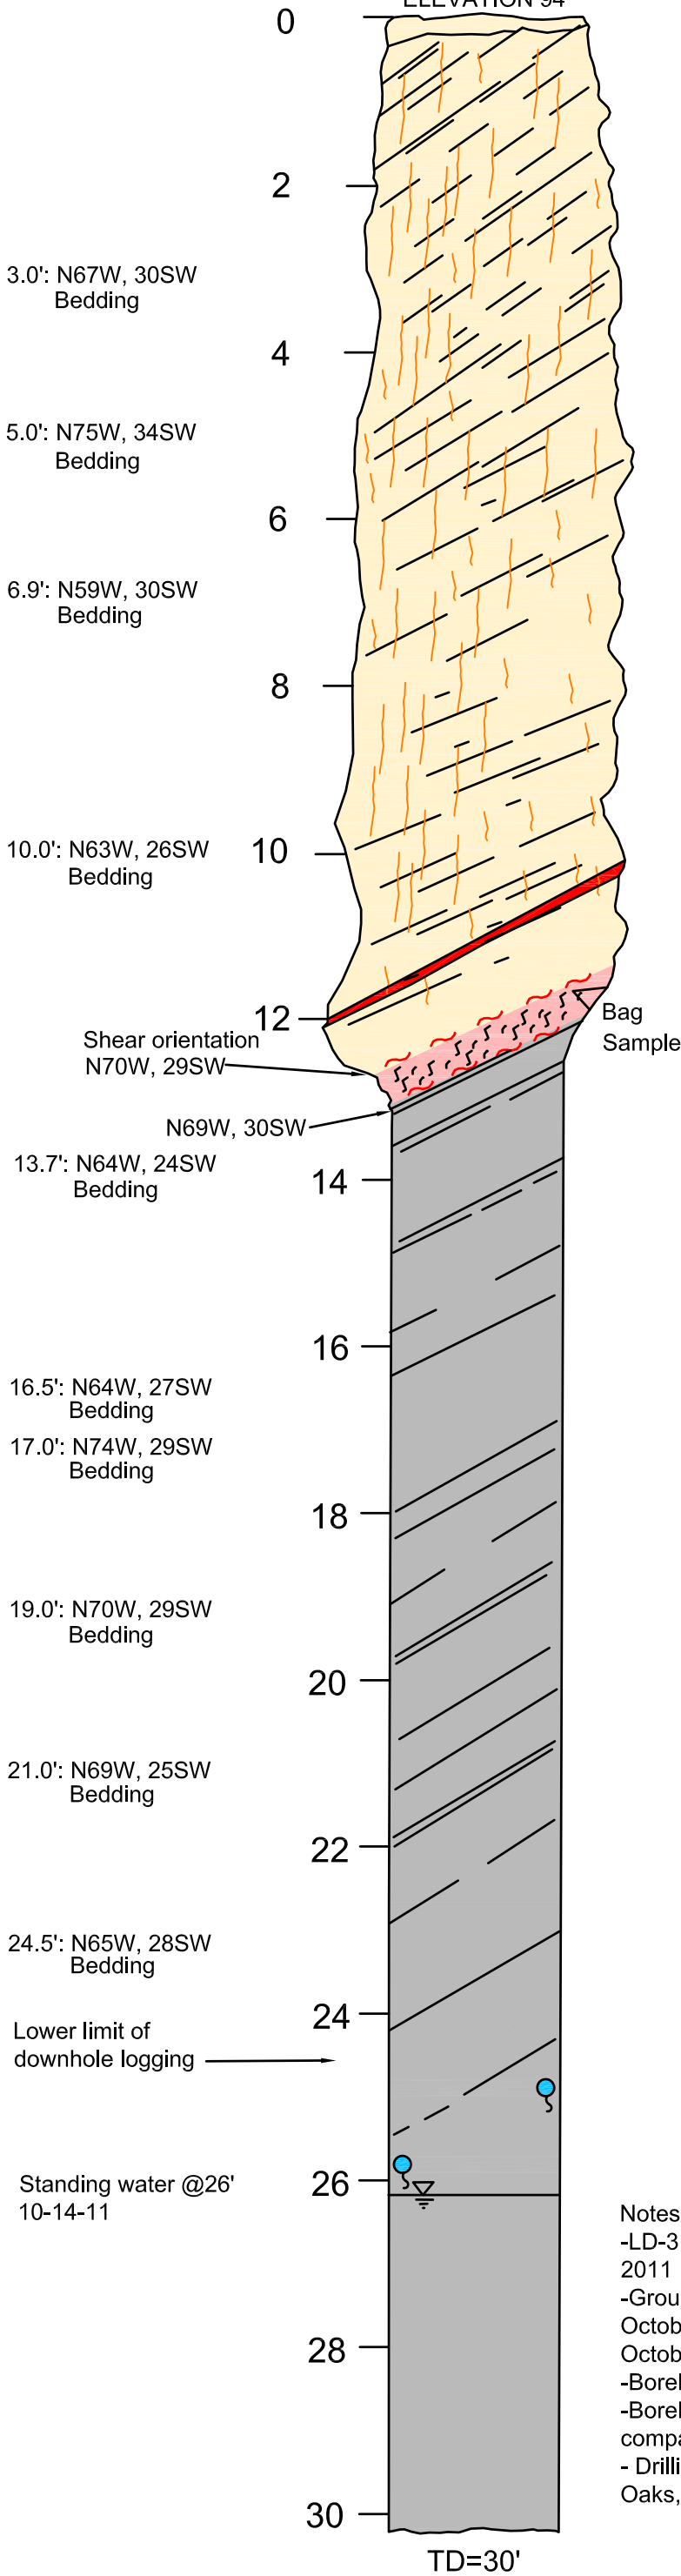
Borehole LD-3 – Borehole LD-3 is located downslope of LD-2 within the trailing edge of the 1978 ECDLL landslide debris, at approximate elevation 93 feet near the southeastern margin of the proposed building envelope. This borehole was excavated near the north-south property line, and several feet onto the 1921 El Camino De La Luz parcel. In Borehole LD-3, we encountered approximately 12 feet thickness of landslide debris characterized by profusely fractured, unstable, ravelly, deeply weathered and weak Monterey Formation materials. At a depth of 12 feet, we encountered a prominent basal landslide shear surface characterized by a 3- to 5-inch thick shear zone with upper and lower bounding shear surfaces that are bedding plane-parallel. Between the upper and lower bounding shears, we documented highly fractured, disrupted, and displaced silty sand and clayey silt with abundant shale rock fragments. The shear zone has an orientation of N70W, 30SW, which is similar to bedding orientations above and below. Clay gouge, paper thin to 0.25-inch in thickness, was observed along the upper and lower contacts of the shear zone, but these gouge zones were discontinuous and disrupted. We interpret this to be the result of dilation (unloading) along the shear zone as the main portion of the landslide evacuated this area and the trailing edge of the 1978 landslide came to rest at this location.

0.0'-12.4'; LANDSLIDE DEBRIS;

0.0'-0.3'; Silty Clay - Dark yellowish brown, dry, roots
0.3'-12.4'; DISRUPTED SHALE; Light gray to yellowish brown, thin-bedded siliceous shale, intensely to closely fractured, friable to weak strength, abundant high-angle open fractures, unstable borehole walls ravel and cave easily; shale is thinly laminated with siltstone and claystone interbeds, consistent bedding 0-12'

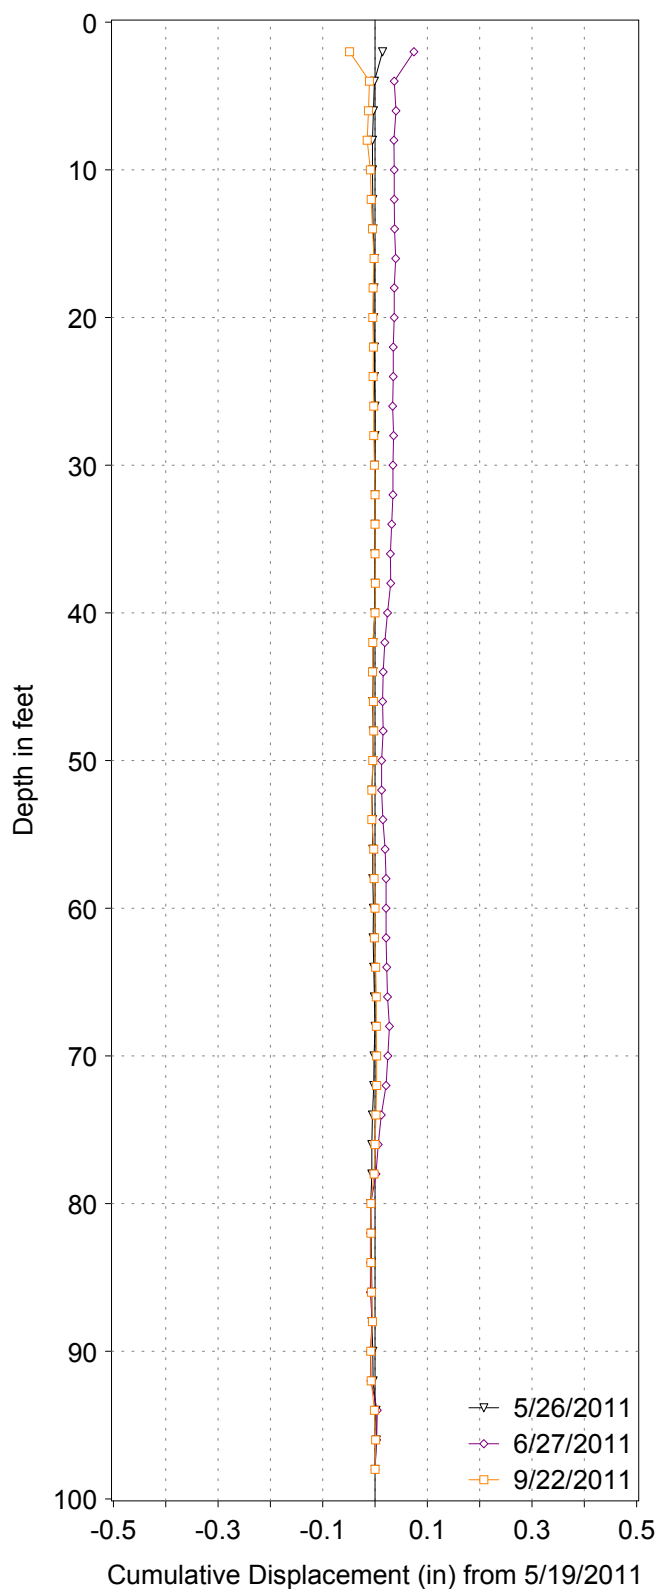
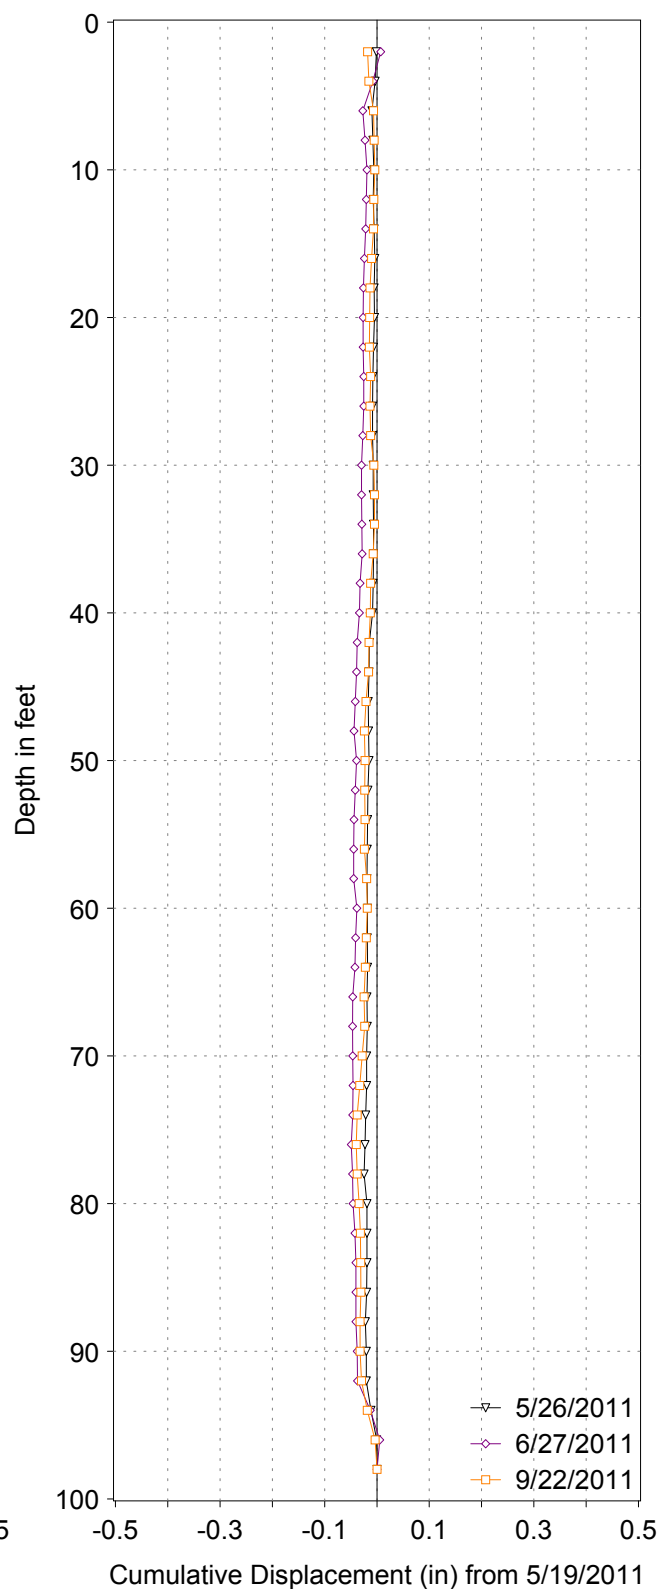
CSA/SI-1

45 feet, and one deep sensor between 88 and 93 feet below ground surface. Piezometers were attached to the sides of the inclinometer casing during installation and grouted in place. Water levels were recorded in these instruments (see attached piezometer graphs in this Appendix) between mid-May 2011 and early January 2012. Groundwater levels have experienced little fluctuation during the monitoring period, and generally correspond with the transition from oxidized to unoxidized bedrock between 22 and 35 feet below the ground surface. The deep and shallow sensors reveal groundwater levels nearly at the same respective elevations, indicating that neither artesian conditions nor perched water tables were present at the site during the measurement period.
